Recreational Boat Collision Accident Research

Volume 1

Miles A. Beam III, P.E.
Senior Project Engineer
Marine Department

Underwriters Laboratories Inc.

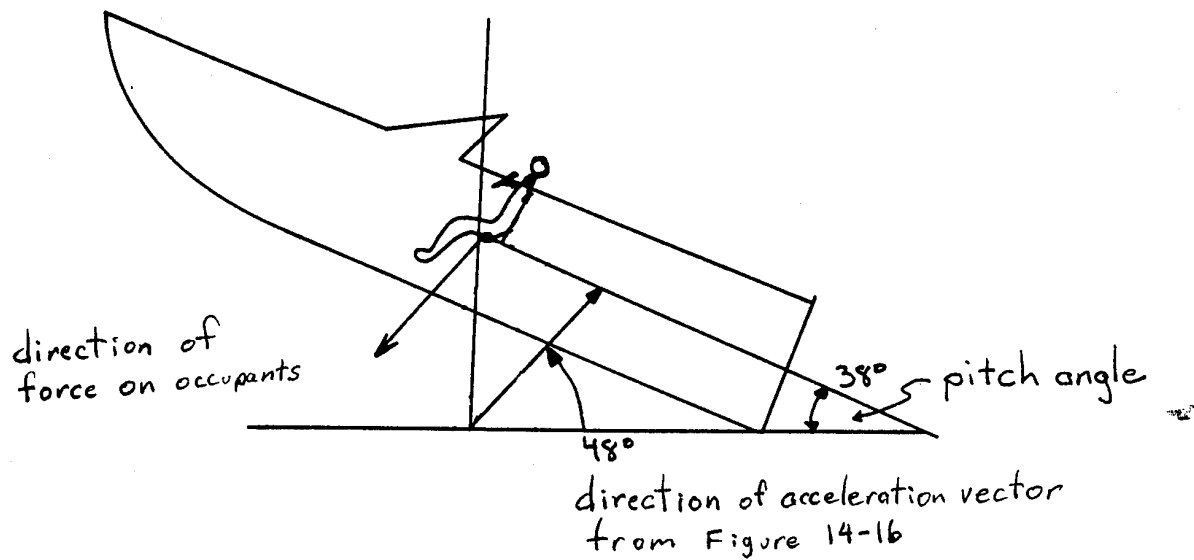
Figure 14-17 shows what the direction of acceleration would be for the values given in the computer model with an increased pitch angle for the bullet boat. In this example, the occupant will feel as though he is being thrust to the floor of the boat. The force is nearly vertical to the trim angle of the boat in this example.

Occupants of the Bullet Boat at the CG Experience a Force Opposite in Direction to the Total Acceleration Vector of the CG.
